# Reformer Tube Inspection and Remaining Life Assessment as per API 579-1/ASME FFS-1

by: Ketan Upadhyaya

TCR Advanced  
Vadodara

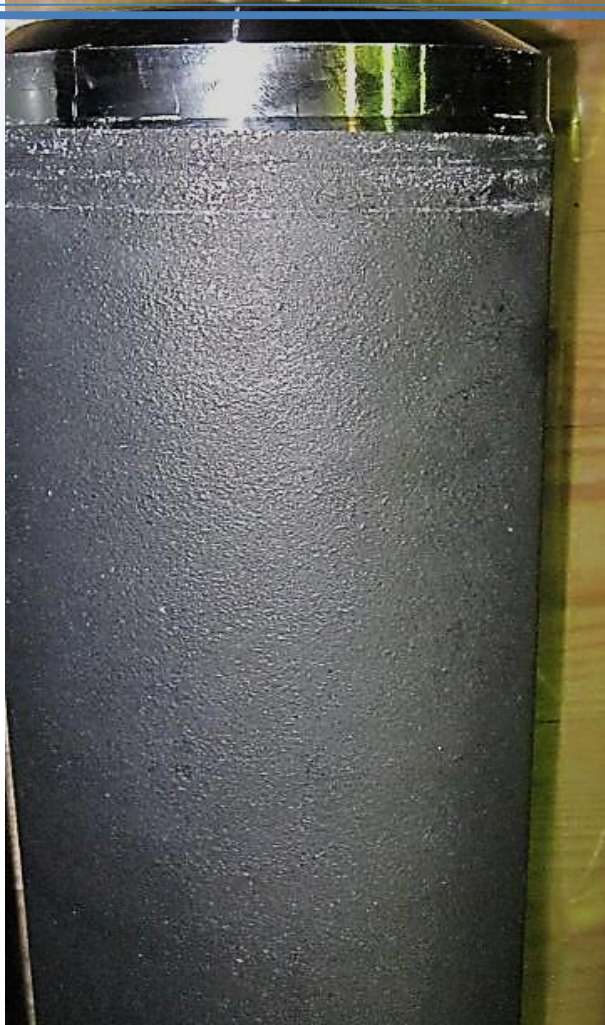
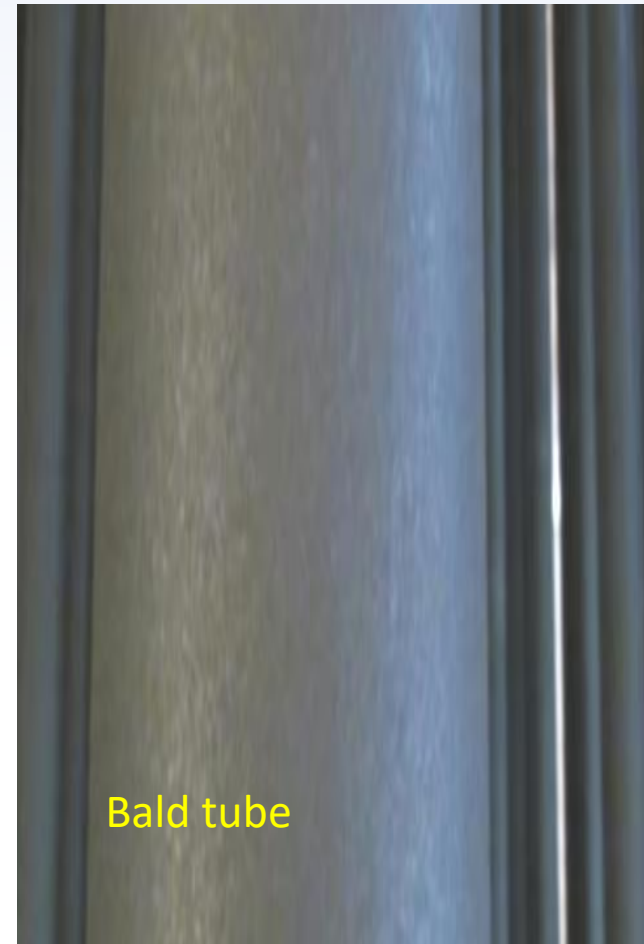
Comparison between two reformer tubes for showing baldness

- Corrosion and oxidation resistance of most materials conventionally used in steam cracking industry relies on formation of a protective chromia ( $\text{Cr}_2\text{O}_3$ ) layer.
- It is noticed that the scale formed on 25Cr-35Ni has a rapid initial growth rate , but at a certain point, intrinsic stresses causes the scale to spall off. New oxide is formed on the spalled areas, and chromium from the alloy is rapidly consumed.

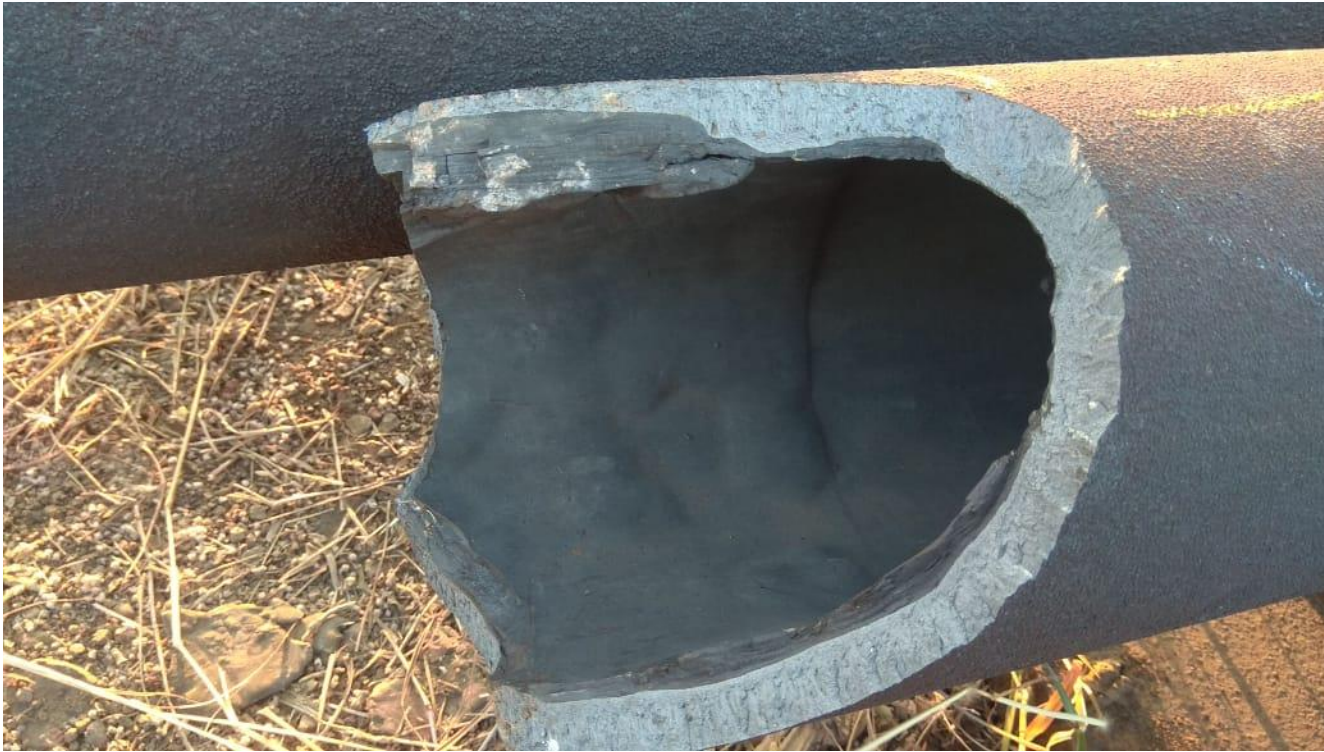
- Internal carburization can be caused by process upset
- Severe carburization can lead to brittle failure

- Internal carburization can be caused by process upset
  - Degradation of catalyst
  - Imbalance of Feed and steam
  - Upstream process upset
- Carburization extent: it is observed up to 50% of wall thickness (from ID side)
- Carburized layer is not sound wall, and hence does not bear the internal pressure
- Severe carburization can lead to brittle failure
  - Brittle fracture can occur during idling time essentially during pressure test, DP test for catalyst check
- Relative magnetic permeability measurements are helpful
- MOCs: Kubota developed AFTALLOY (Al and Si added proprietary grade)

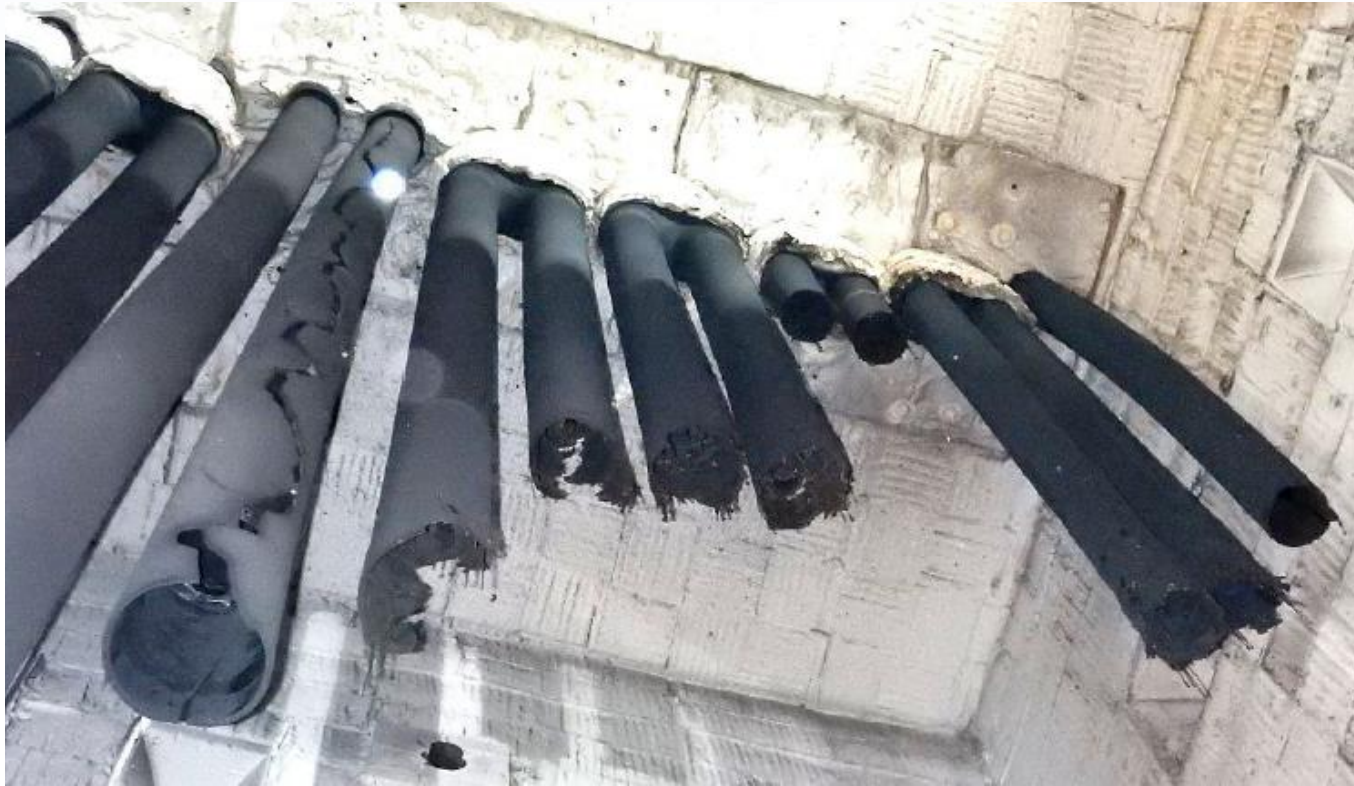
- Sudden change in temperature causes thermal shock that may result in abrupt, catastrophic failure of tubes.

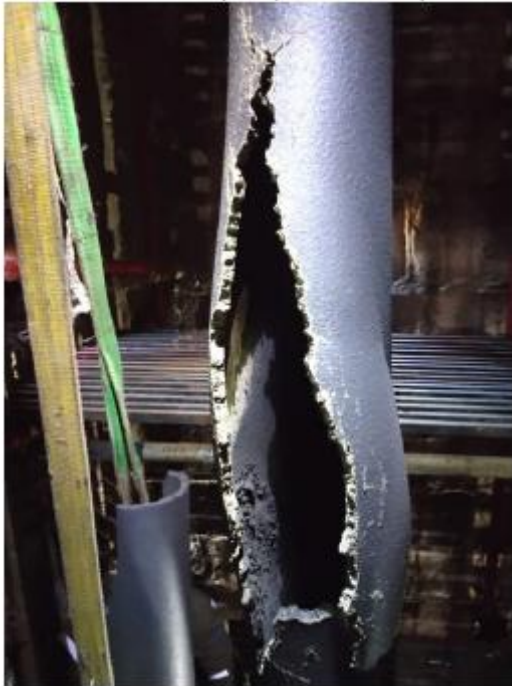
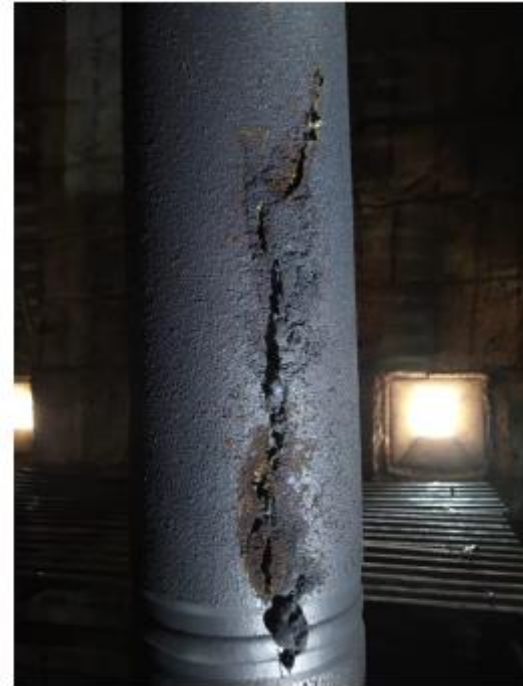
- Mis-alignment of burners and / or their clogging creating disturbance in flue gas path can lead to direct flame impingement to the tubes.
- As a result, tubes tend to damage locally by overheating.

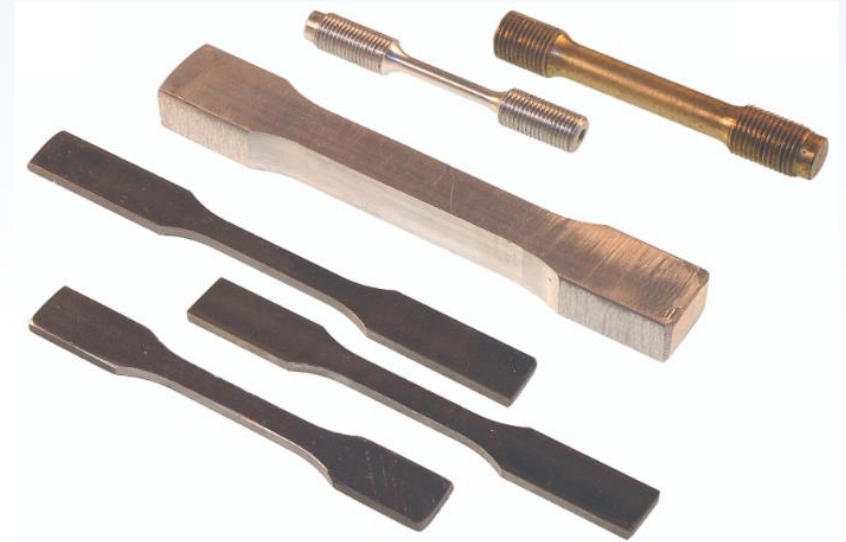
- Usually a tensile bar
- Dead load applied
- Strain is plotted with time
- Test usually ends with rupture (failure)

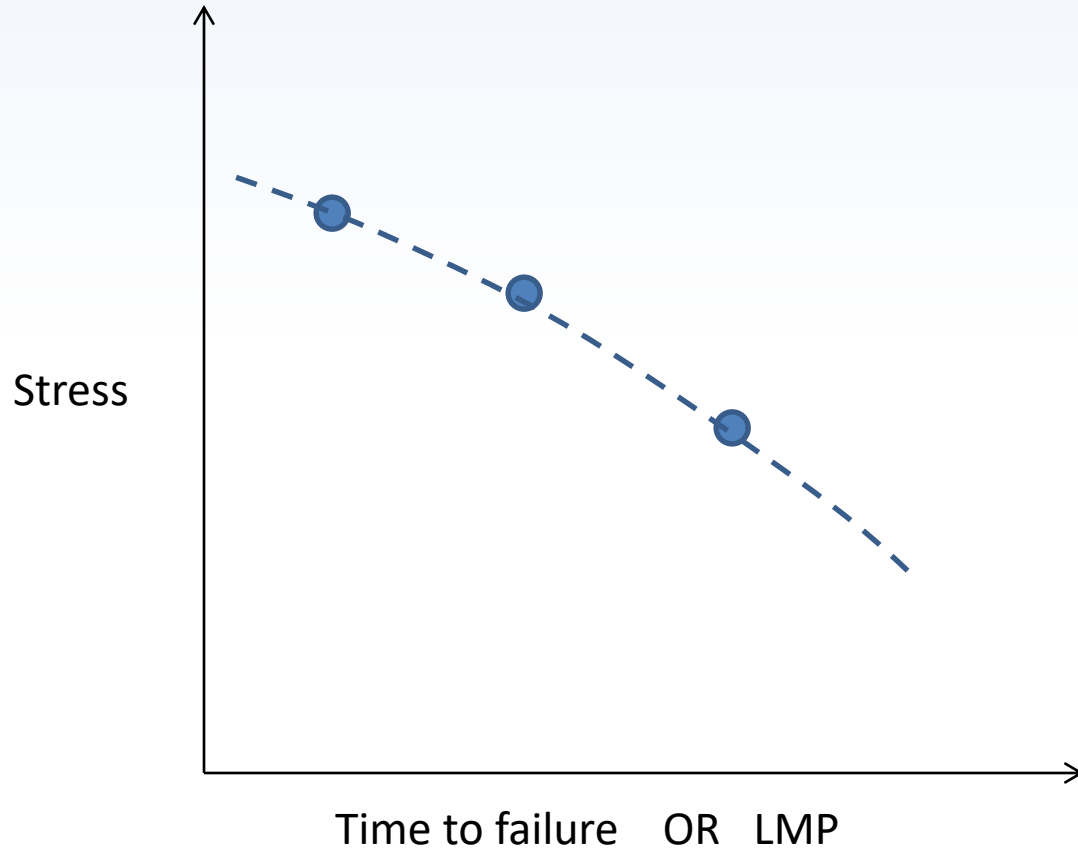
As stress decreases, time to rupture increases

As temperature decreases, time to rupture increases

A fair degree of accuracy can be gained with lower stress values and higher test temperature regimes

Plotted when test temperature is constant

Plotted when test temperature is varied

- Having multiple test results handy, prepare the stress v/s LMP curve.
- Interpolate the actual (operating) stress and determine LMP
- Determine the residual time by averaging the trend on tube metal temperature using LMP equation

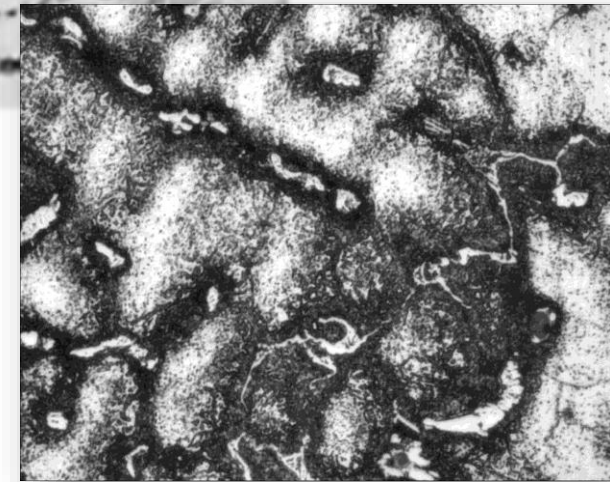
*Dendrite boundary*

*Secondary carbides*

*Creep voids*

TR Mode ultrasound wave attenuates by:

- Scattering at dendrite boundaries
- Secondary precipitates
- From creep damage, seen as formation of voids
- From interlinked voids (fissures) at mid-wall

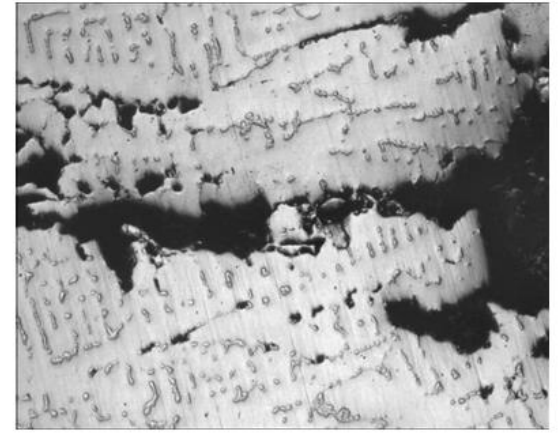
*Alloy HK40, Service exposed 29 years,*

Primary carbides at dendritic grain boundaries. Outer and inner edges show oxidation cracking. Aligned cavities are observed along primary carbide at core. The secondary carbides are nearly absent within the grains.

Sound attenuation measured is 56 to 62 dB

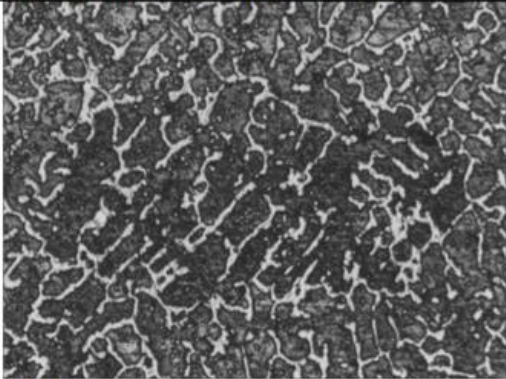
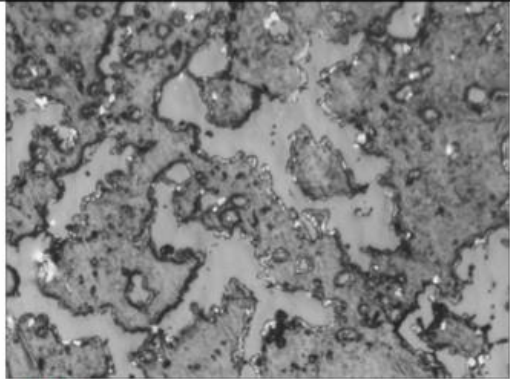
| comments | Microstructure shows network of primary and secondary precipitates including carbides in the matrix of austenite in a cast structure. The primary and secondary precipitates have coarsened. | |

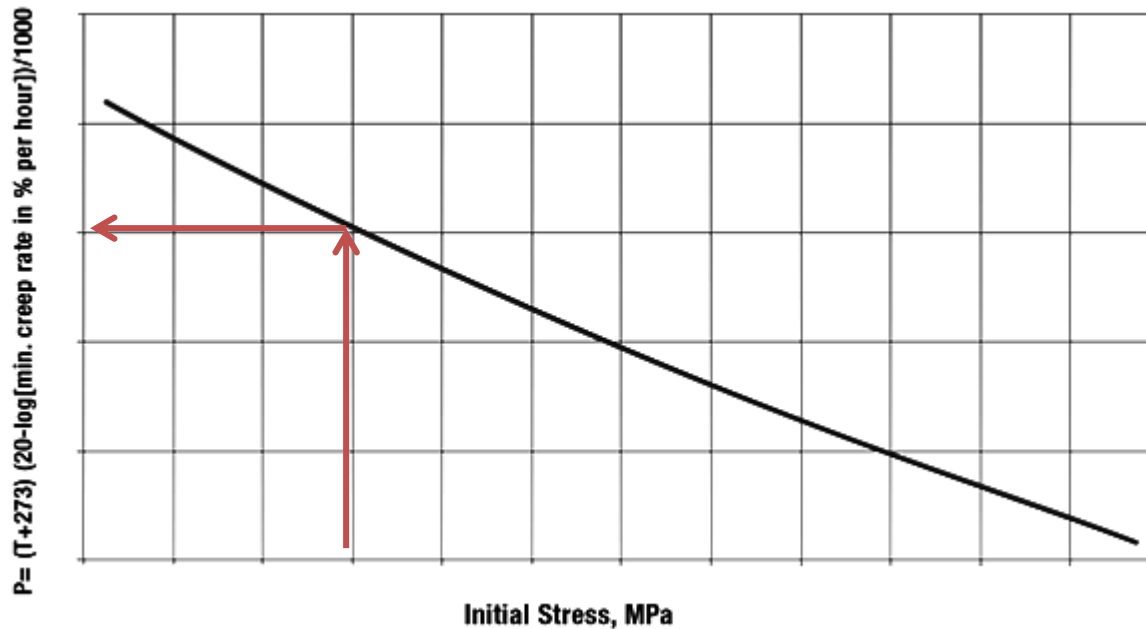
$$(T+273) = P / [20 - \text{Log} (\text{creep rate})]$$

The creep strain is calculated from maximum increase in diameter along length of tube.

Dividing the total creep strain to number of hours the tube is operated.

The creep strain rate along with the initial stress for each interval of loading provides input parameters for calculation of effective tube skin temperature.

The curves for creep strain rate v/s stress are available with service providers through series of actual creep rupture tests.
